# Manhole Inspection Summary

Manhole # S690\_\_004MH

**Location** Address: **6600 Gary Ave.**

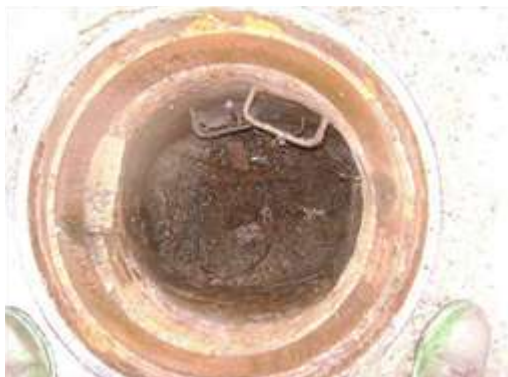
Defect 2

1 in. frame offset

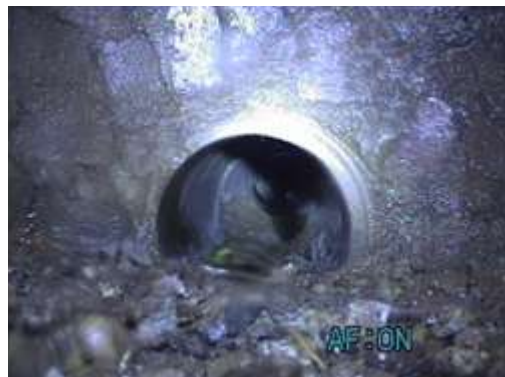
Defect 1

deposit settled gravel [dsgr] in trough and front of outgoing 12 oclock pipe connection

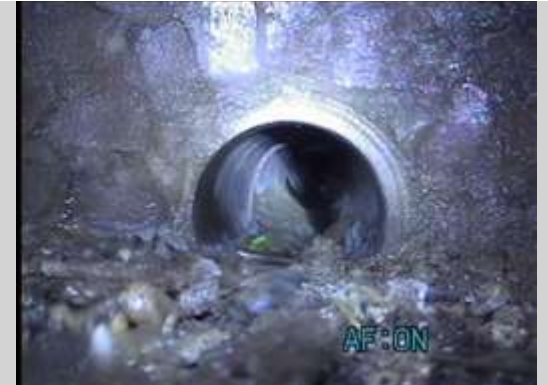
12 O'Clock Outflow

Deposits: ☐ None ☒ **Mud** ☒ **Gravy** ☒ **Debris** ☐ Grease

Silt Depth: **3** (in.) Deposits Extent: **Medium**
